TSB 09-05-00

Spark knock and oil consumption due to intake manifold pan gasket oil leak.

Date: Feb.25, 2000

Models: 1994-1999 BR/BE Ram truck V6, V8

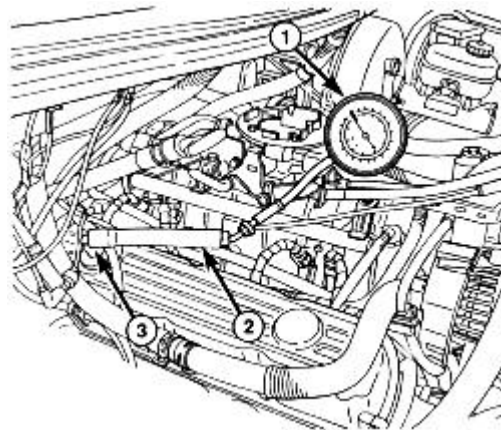
1 - VACUUM / PRESSURE GAUGE
2 - BREATHER HOSE
3 - VALVE COVER BREATHER HOSE PORT

1. Allow the engine to reach normal operating temperature.
2. Stop the engine.
3. Disconnect the breather hose from the air cleaner.
4. Attach a vacuum I pressure gauge to the end of the breather hose (Figure 1).

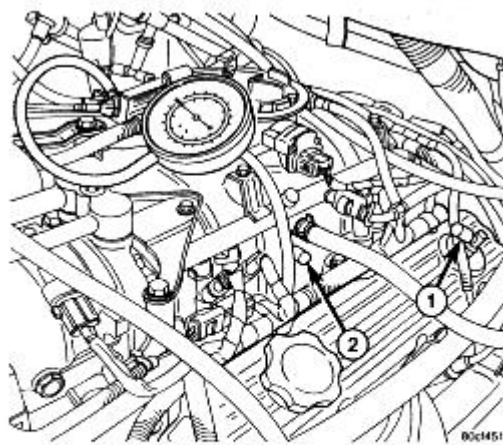
FIGURE 2

1 – CAPPED OFF PCV VALVE
2 – CAPPED OFF INTAKE MANIFOLD PCV PORT

5. Disconnect the PCV valve hose from the intake manifold.
6. Seal off the intake manifold PCV valve hose port opening.
7. Seal off the open end of the PCV valve hose (Figure 2).

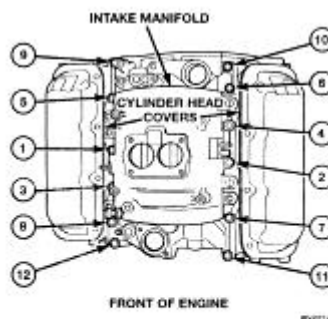
FIGURE 4

3.9L Intake Manifold Bolt Tightening Sequence

3.9L Plenum Pan Bolt Torque Procedure		
STEP	WHICH BOLT	TORQUE
1	All Bolts	5.4 Nm (48 in. lbs.)
2	All Bolts	9.5 Nm (84 in. lbs.)
3	Check All Bolts	9.5 NM (84 in. lbs.)
3.9L Intake Manifold Flange Bolt Torque Procedure		
STEP	WHICH BOLT	TORQUE
1	1 and 2	1.4 NM (12 in. lbs.)
2	1 and 2	2.7 NM (24 in. lbs.)
3	1 and 2	4.1 NM (36 in. lbs.)
4	1 and 2	5.4 NM (48 in. lbs.)
5	1 and 2	6.7 NM (60 in. lbs.)
6	1 and 2	8.1 NM (72 in. lbs.)
7	3 through 12	8.1 NM (72 in. lbs.)

8	Check All Bolts	8.1 NM (72 in. lbs.)
9	All Bolts	16.3 NM (12 ft. lbs.)
10	Check All Bolts	16.3 NM (12 ft. lbs.)

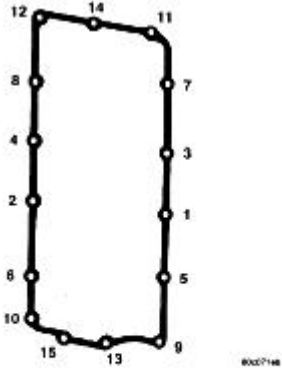
FIGURE 5

5.2L / 5.9L Intake Plenum Pan Bolt Tightening Sequence

5.2L / 5.9L Plenum Pan Bolt Torque Procedure		
STEP	WHICH BOLT	TORQUE
1	All Bolts	5.4 NM (48 in. lbs.)
2	All Bolts	9.5 NM (84 in. lbs.)
3	Check All Bolts	9.5 NM (84 in. lbs.)
5.2L / 5.9L Intake Manifold Flange Bolt Torque Procedure		
STEP	WHICH BOLT	TORQUE
1	1 and 4*	1.4 NM (12 in. lbs.)
2	1 and 4*	2.7 NM (24 in. lbs.)
3	1 and 4*	4.1 NM (36 in. lbs.)
4	1 and 4*	5.4 NM (48 in. lbs.)
5	1 and 4*	6.7 NM (60 in. lbs.)
6	1 and 4*	8.1 NM (72 in. lbs.)
7	5 through 12	8.1 NM (72 in. lbs.)
8	Check All Bolts	8.1 NM (72 in. lbs.)
9	All Bolts	16.3 NM (12 ft. lbs.)
10	Check All Bolts	16.3 NM (12 ft. lbs.)

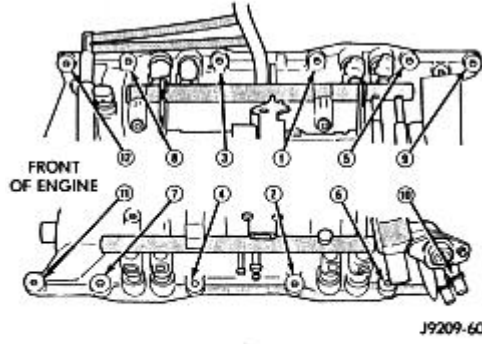
FIGURE 6

5.2L / 5.9L Intake Manifold Bolt Tightening Sequence

* The bulletin clearly says to tighten bolts **1 and 4**, but this is probably a typo because the service manual says to tighten bolts **1 through 4**, and nowhere in the TSB does it say to tighten bolts 2 and 3, which would only be tightened to 12 ft. lbs when you reach step 9.
