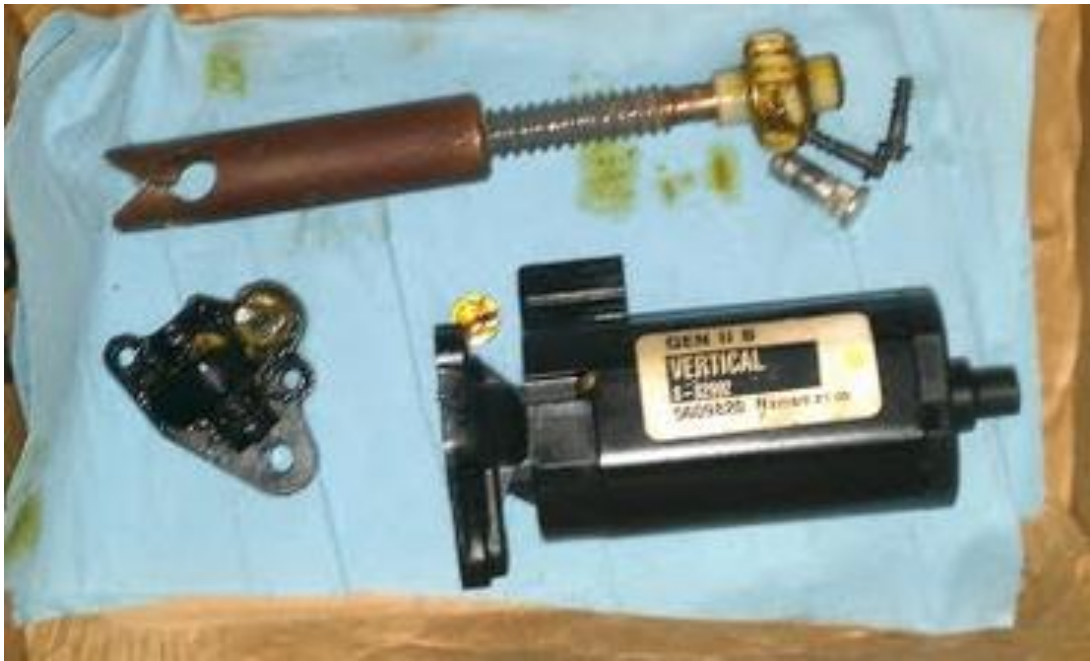
Here is a picture of the rear vertical motor with the front cover taken off so that you can see the broken gear.

There are pieces of broken gear on the shaft gear and in the housing.
